**PHOTOGRAPHIC SURVEY OF THE WEST GABLE OF KILBRIDE CHAPEL
AND ARCHAEOLOGICAL EXCAVATION OF RUBBLE ON BOTH SIDES OF
THE WEST GABLE ENTRANCE.**

Client: Friends of Kilbride

Produced by Clare Ellis of Argyll Archaeology 25th August 2020

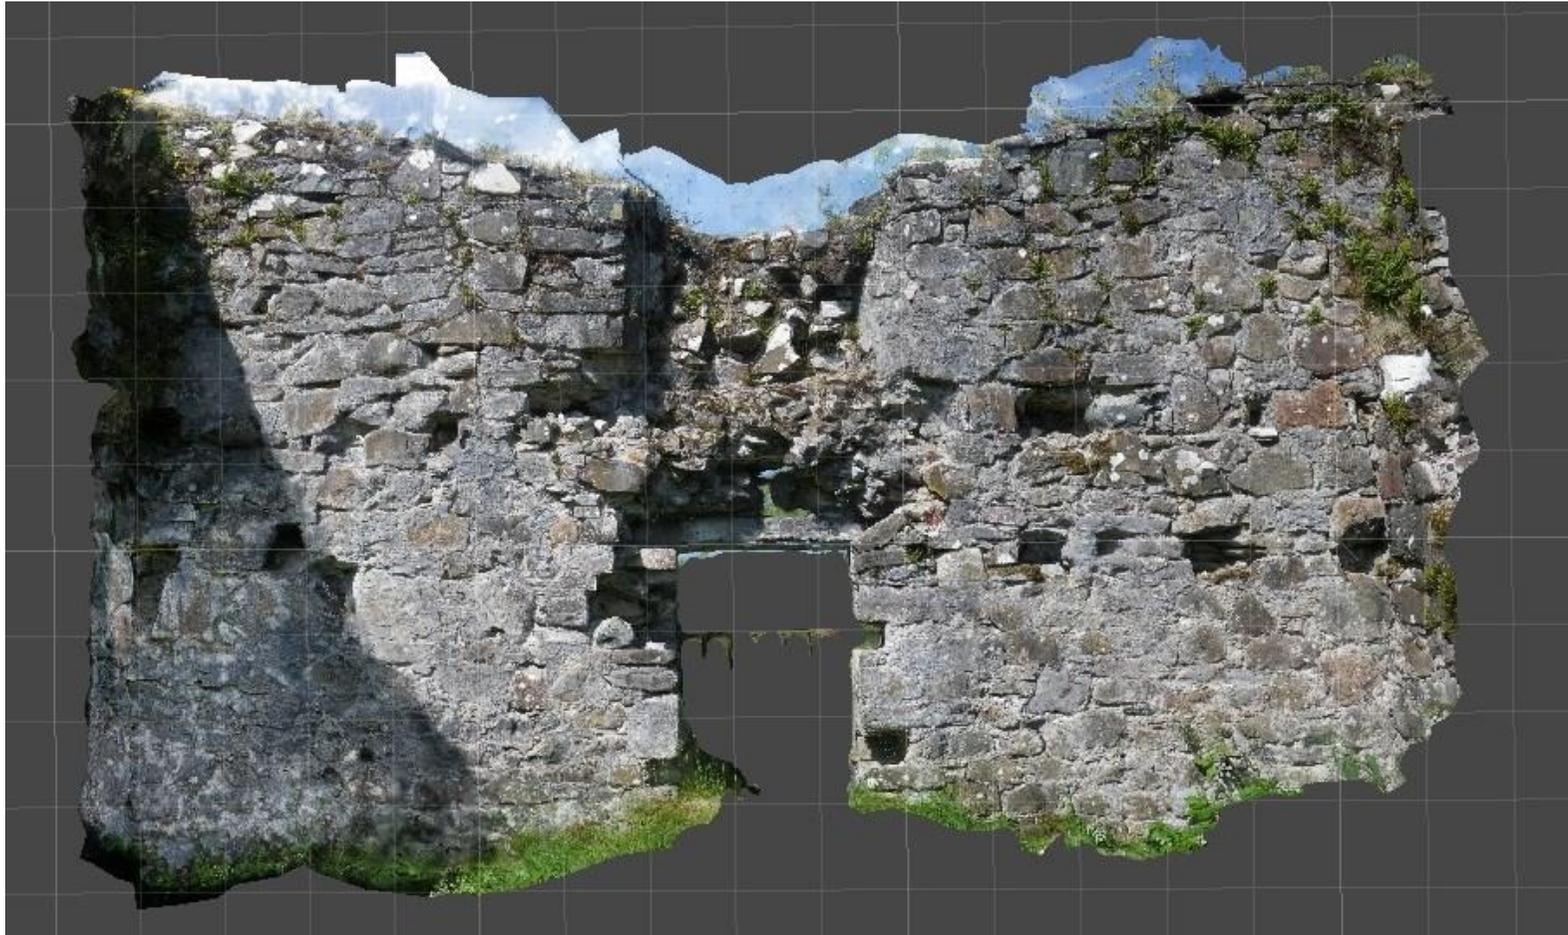
The west gable wall is constructed from whinstone (basalt the dominant geology of the immediate area), sub-rounded beach/glacial cobbles some of which were split prior to use, and the odd piece of slate; very few of the stones appear to have been deliberately shaped (Fig. 2). The wall is about 75cm deep. The wall was mortared, with small patches of internal plaster surviving. An upper line of 9 joist holes, some of which were lined with narrow pieces of stone were recorded just above the level of the door lintel and roughly 150cm below the top of the wall at the north end. The northernmost measured 30cm vertically and 18cm horizontally with a hole for the wood measuring 17cm x 12cm. The adjacent slot and the next in the sequence would have each held a beam some 10cm x 6cm. The spacing between the slots is not even but ranges between 37cm and 30cm.

There is a second lower line of 8 joist holes of varying dimensions, 4 located either side of the doorway. These may be the original joist holes of an internal gallery (?) which would have had to have been raised when the later entrance was created through the west gable (see below).

The wall above the door lintel was in an extremely poor state of repair and was a single stone thick in places. The bevelled nature of the wall above and either side of the door lintel demonstrates that the stone is a rubble infill of a former window about 110cm of which survives. The window widened into the interior of the church to about 150cm in width. An area of the wall above the door lintel and below the bevelled window frame has been removed and infilled with rubble, this was clearly done to allow for the later door lintel and frame to be tied into the west gable wall. Four horizontal full wall width beam slots presumably held wooden beams to which the wooden doorframe was anchored. The church was subject to significant alteration in 1744 when the windows were enlarged and the southern entrance blocked up; the creation of a western entrance was probably one part of these alterations.

Fig 2. The internal elevation prior to the start of works.

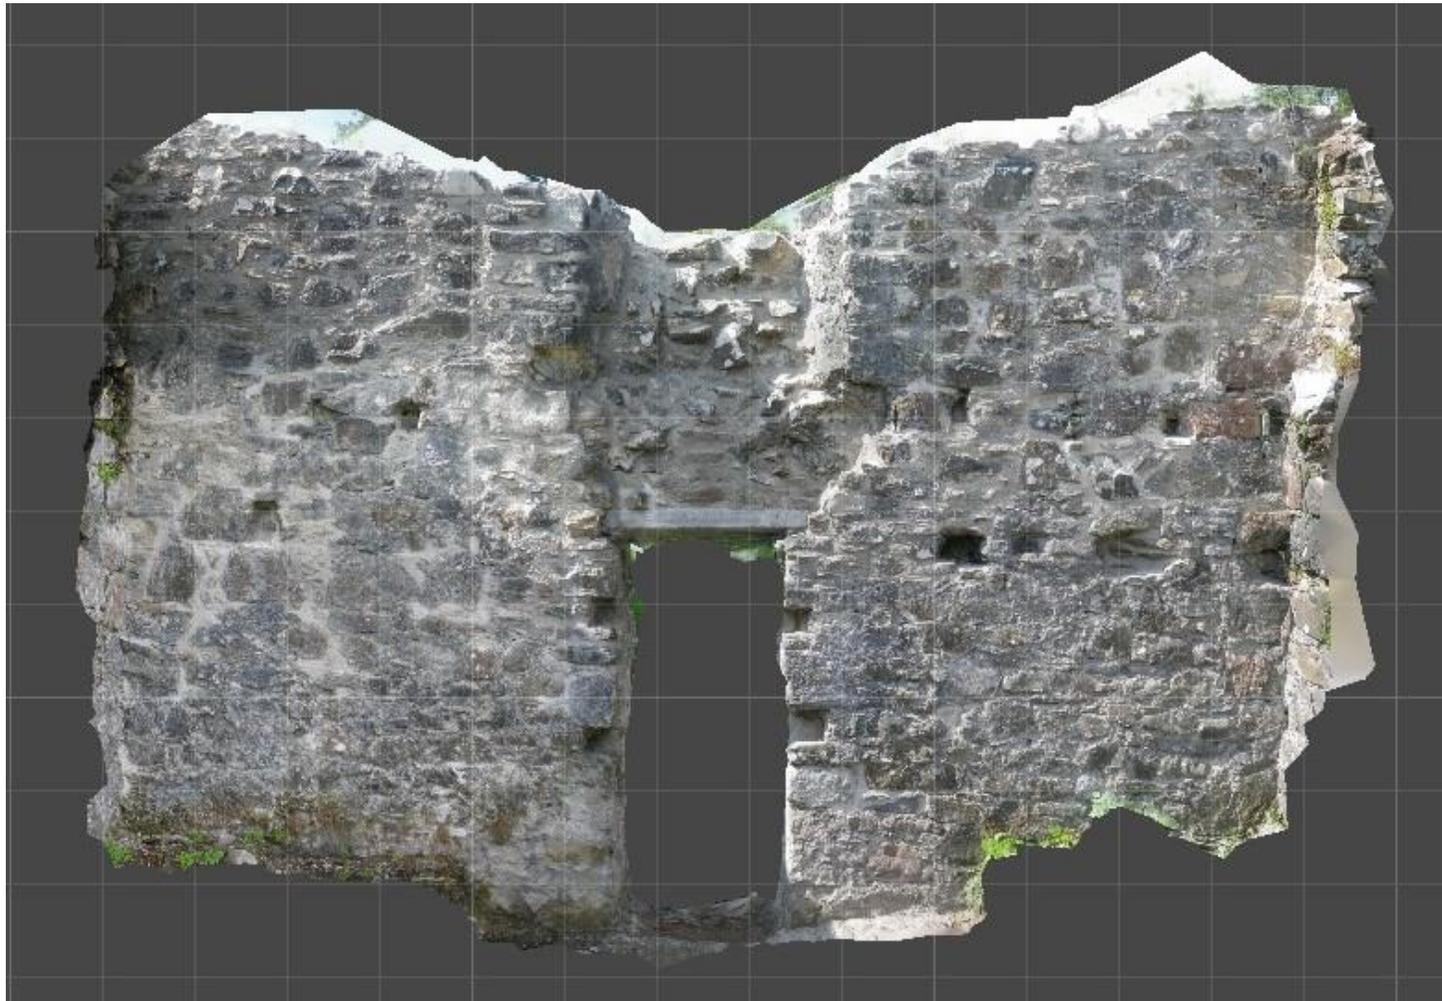
Fig. 3. The internal elevation following the consolidation works and prior to backfilling of Trench 1.

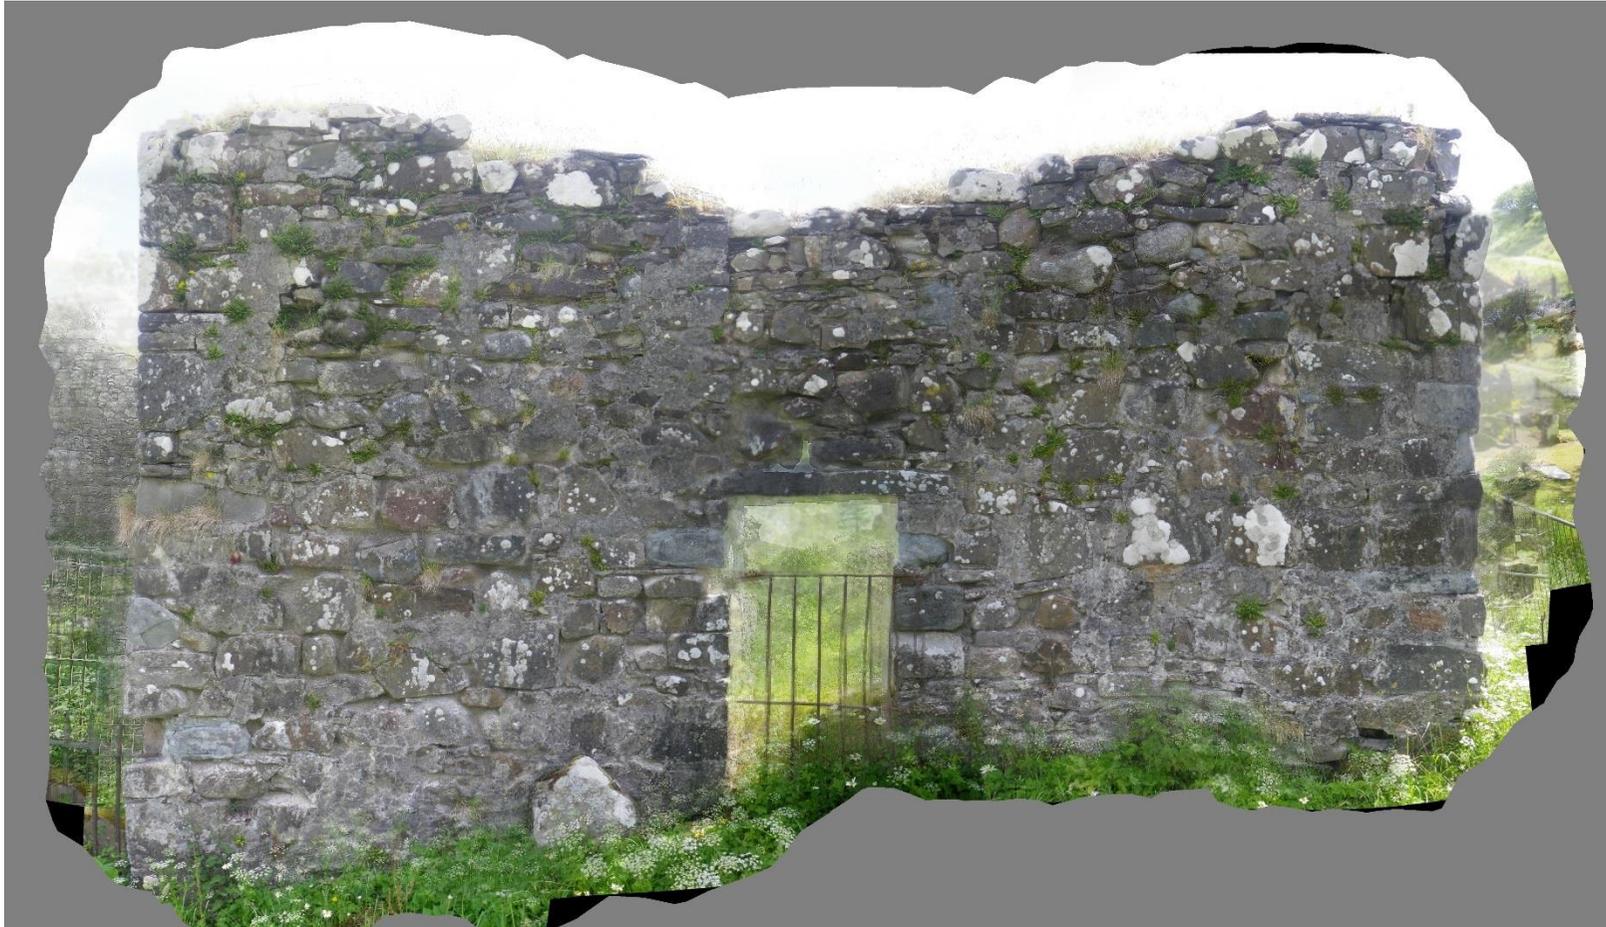
The stone of the external elevation is similar in composition to that recorded in the internal elevation (Fig. 4). However, a small number of stones used in the northern side of the doorway are of a white/cream sandstone and this stone is potentially the same sandstone that was used in the drip courses, in the stone door and window frames and in decorated elements such as the dog-tooth mouldings of the medieval cathedral located on the Isle of Lismore. The sandstone is thought to have been source from Morvern or perhaps from Carsaig Bay on the Isle of Mull as none occurs naturally on Lismore. The identification and source of the sandstone at Kilbride would have to be confirmed by a specialist but the implication is that the cream sandstone was also used at Kilbride in the 13th century chapel to create crisp architectural details and striking door and window frames and these blocks now forming part of the 18th century chapel west door were re-used from the original medieval structure. A piece of moulded stone (geology not identified but not thought to be sandstone) has clearly been re-used in the west door and may have originated in an earlier medieval door or window frame (Fig. 5). A few dressed blocks of red sandstone were noted in the exterior elevation and these too are likely to have been reused from an earlier structure; however, red sandstone occurs locally and may have been sourced within the glen. The blocked window is clearly visible in the external elevation and is especially clear on the northern side (Fig. 4). Following the partial demolition of the church the remaining ruin was consolidated and a concrete capping placed on the top of the wall, the cracked and fragmented remains of which were removed during the consolidation of the west gable.

Fig. 4. The external elevation prior to the start of works

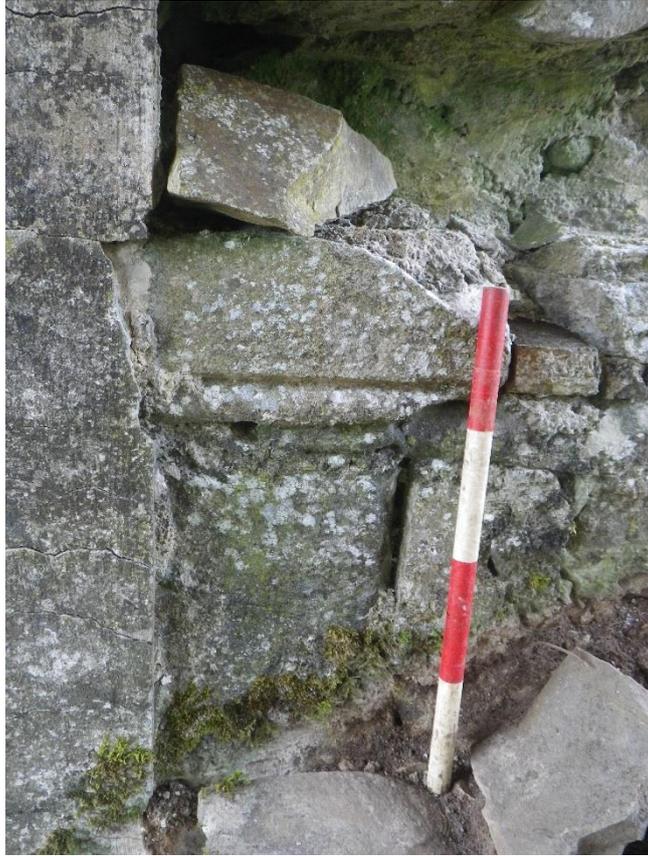
Fig. 5. Moulded stone in the doorway of the west gable, this stone appears to have been re-used from an earlier structure

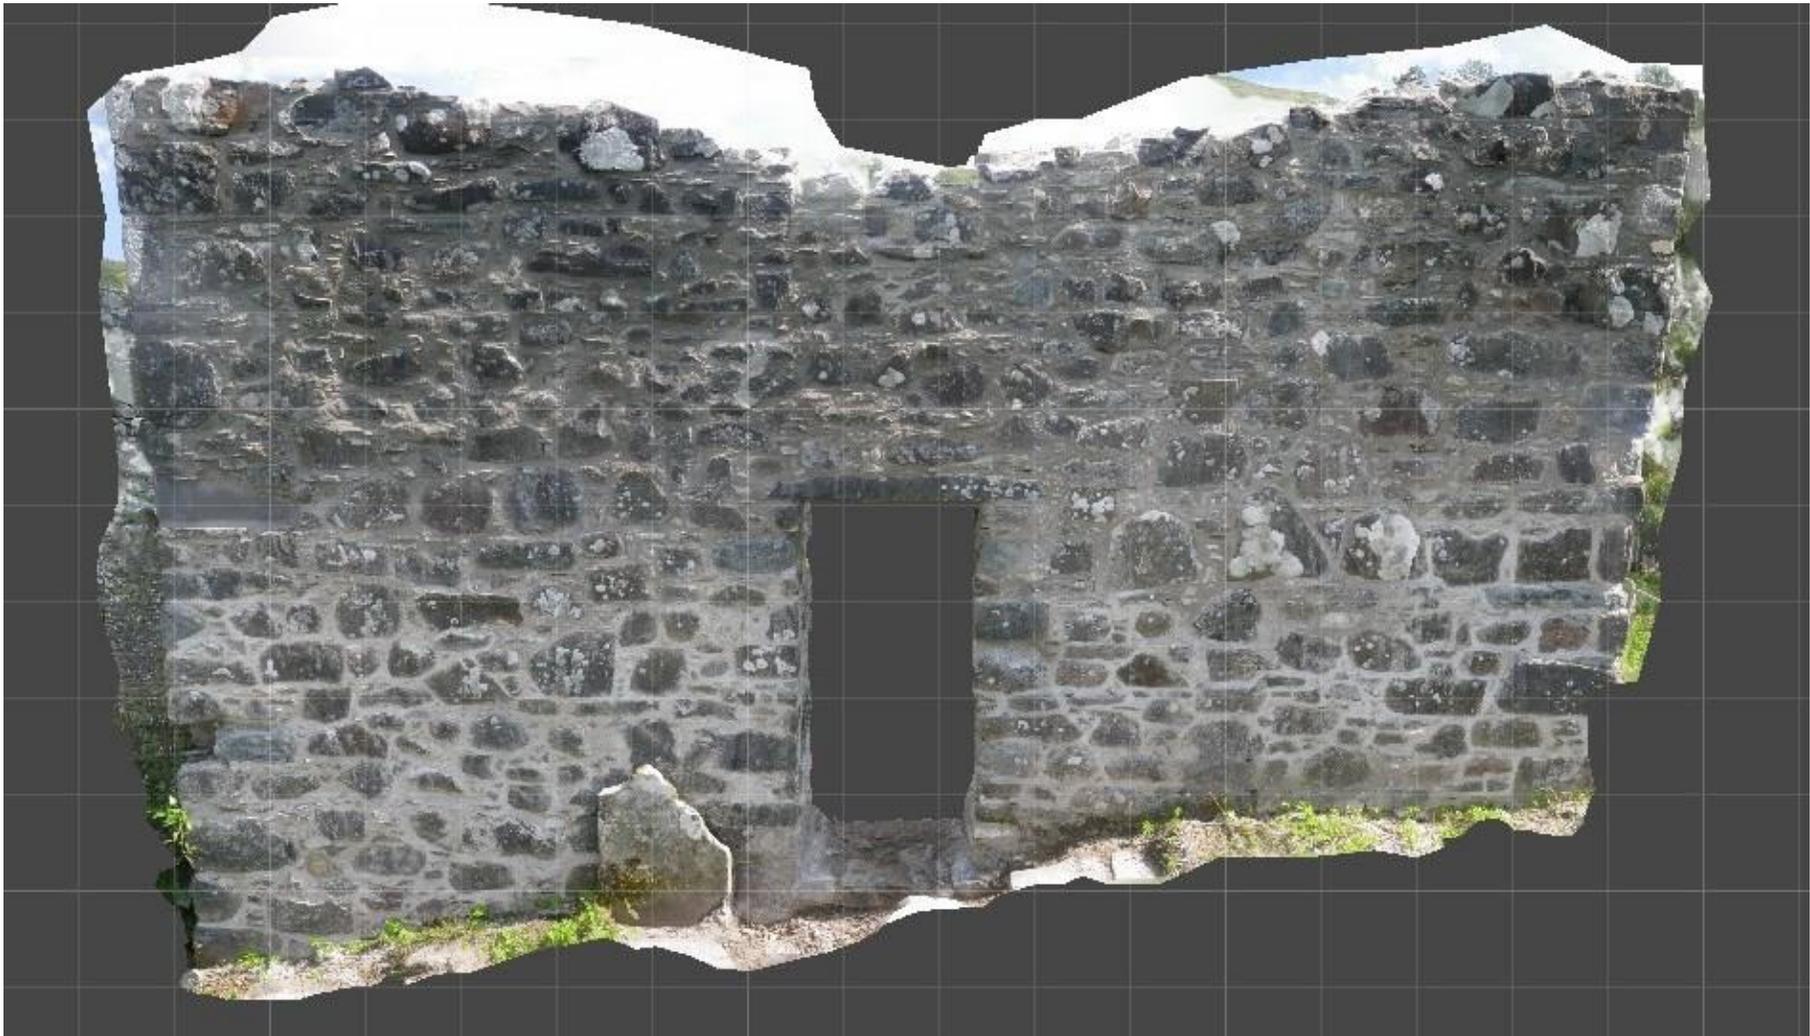
Fig. 6. The external elevation following its consolidation.

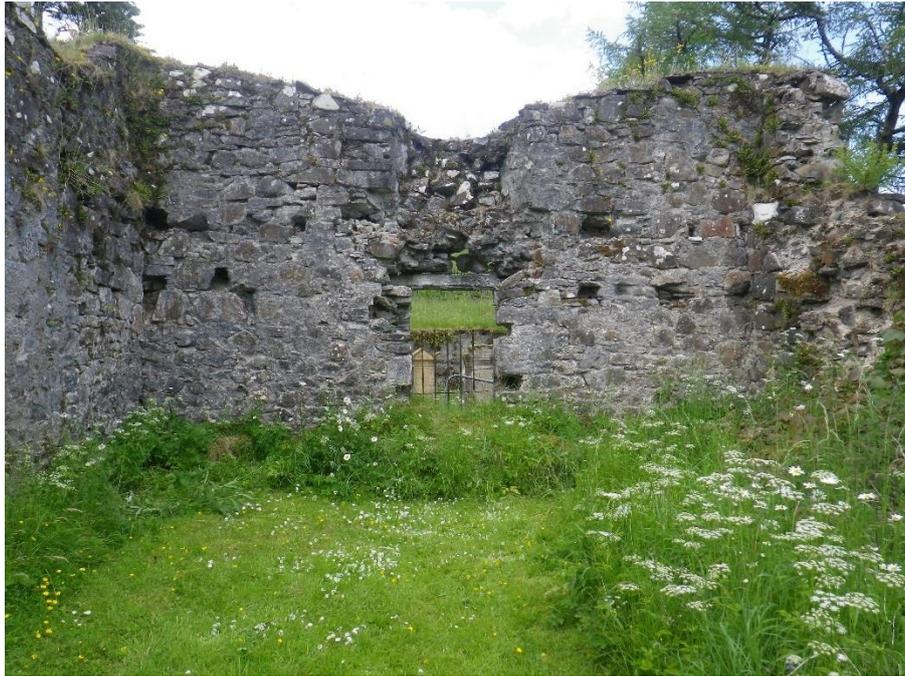
Fig. 6. Interior elevation of the west gable with pile of grass covered stone rubble in front of the entrance

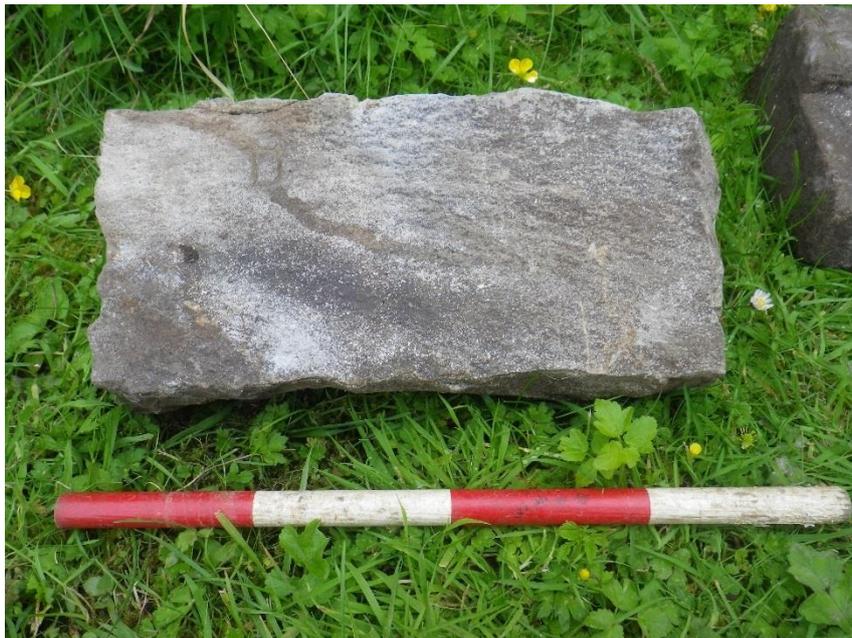
Fig. 8. Carved basalt stone with the letter B in the top left-hand corner.

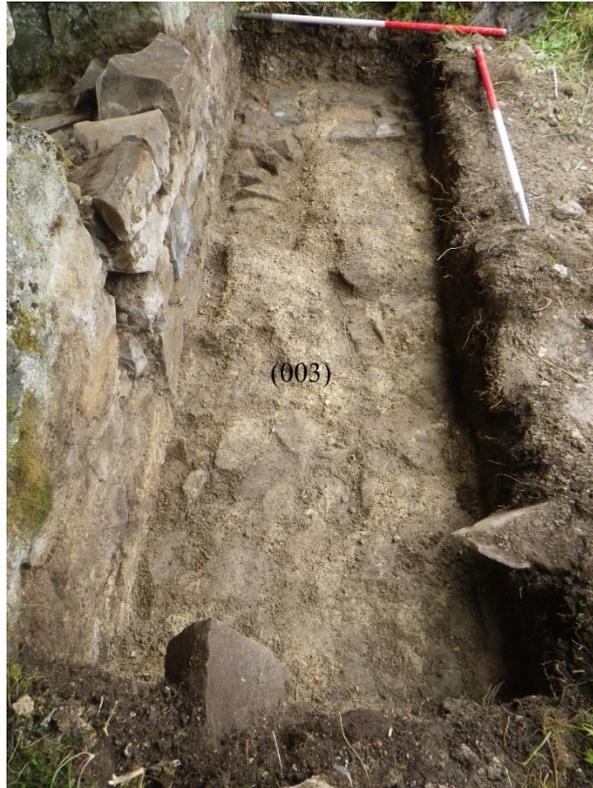
Fig. 9. Trench 1, trampled collapsed wall plaster (003) overlying the cobbled floor (005).

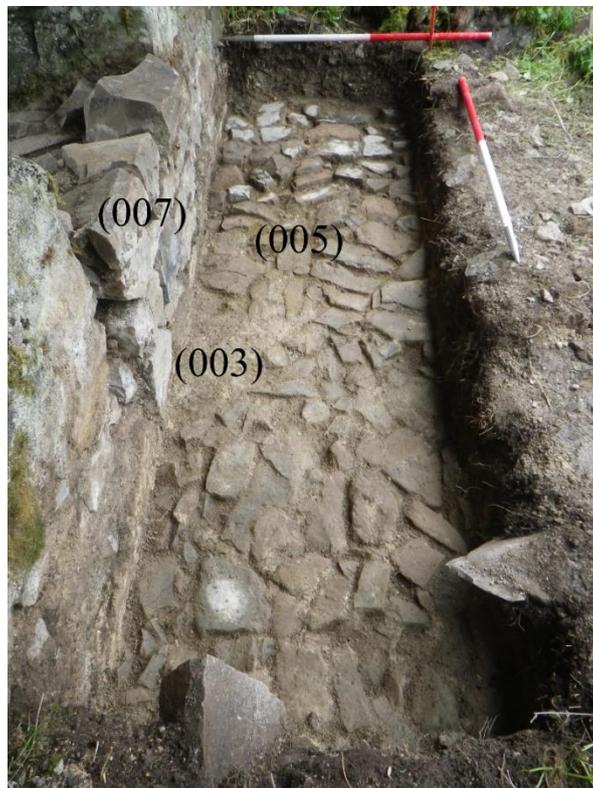
Fig. 10. Trench 1, the cobbled floor (005), with some trampled wall plaster (003) next to the blocking wall (007).

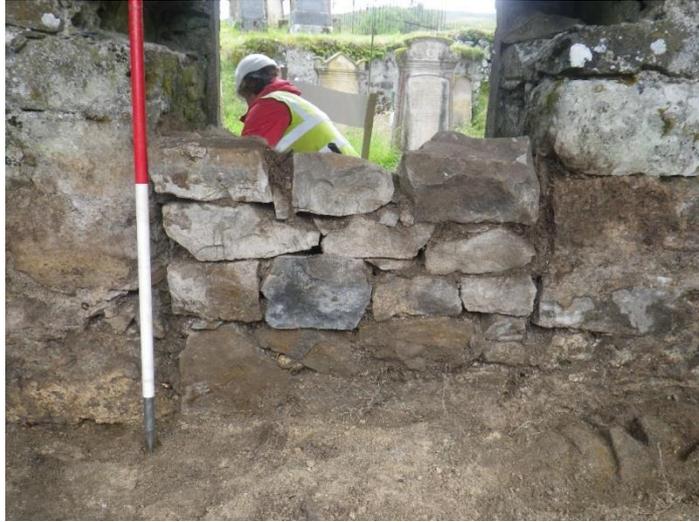
Fig. 11. Trench 1, in situ wall plaster at the base of the wall and the blocking drystone wall (007).

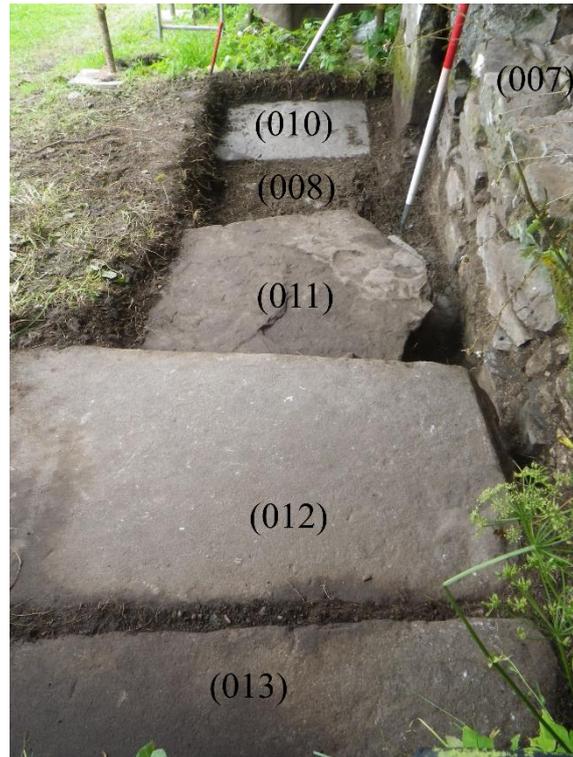
Fig. 12. Trench 12 with turf and topsoil removed showing the surfaces of the re-laid grave slabs and the blocking wall (007).

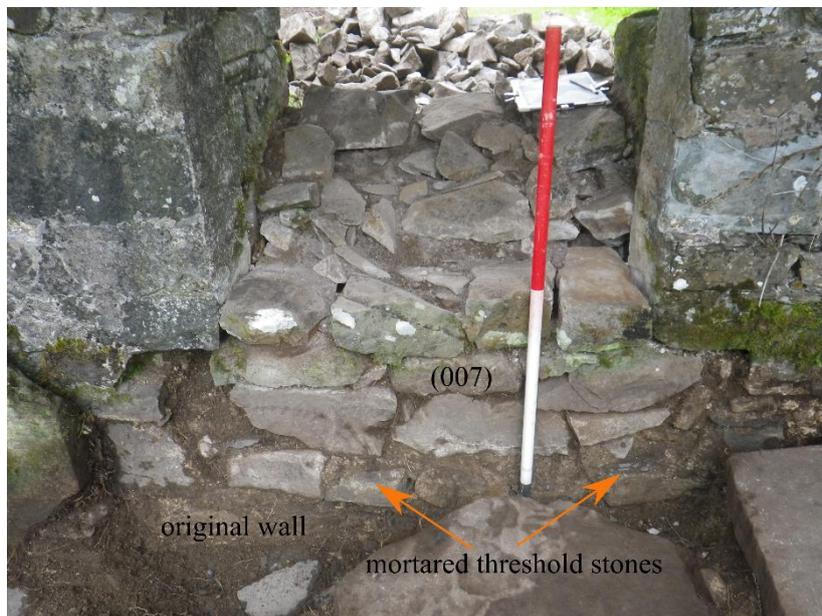
Fig. 13. Mortared in threshold stones of the new west entrance keyed into the pre-existing church wall. The threshold stones are overlain by the later blocking drystone wall (007).

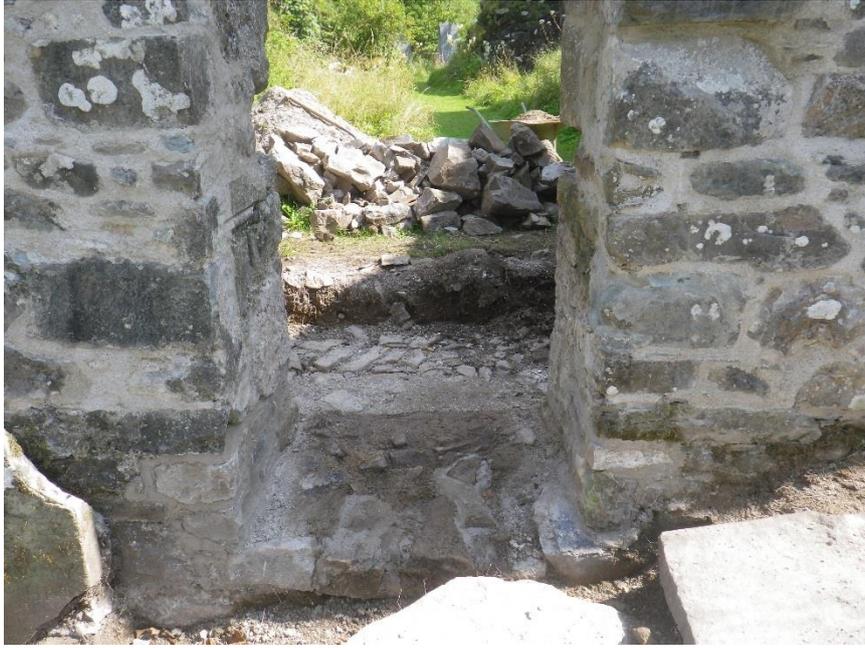
Fig. 14. The extension of the cobbled surface through the west door.
